**CONSENT ORDER
ISSUED UNDER THE
WATER POLLUTION CONTROL ACT
WEST VIRGINIA CODE, CHAPTER 22, ARTICLE 11**

TO: Mountain Valley Pipeline, LLC
Attn: Robert J. Cooper
Senior Vice President, Engineering and Construction
625 Liberty Ave, Ste 1700
Pittsburgh, PA 15222

DATE: April 19, 2019

ORDER NO.: 8951

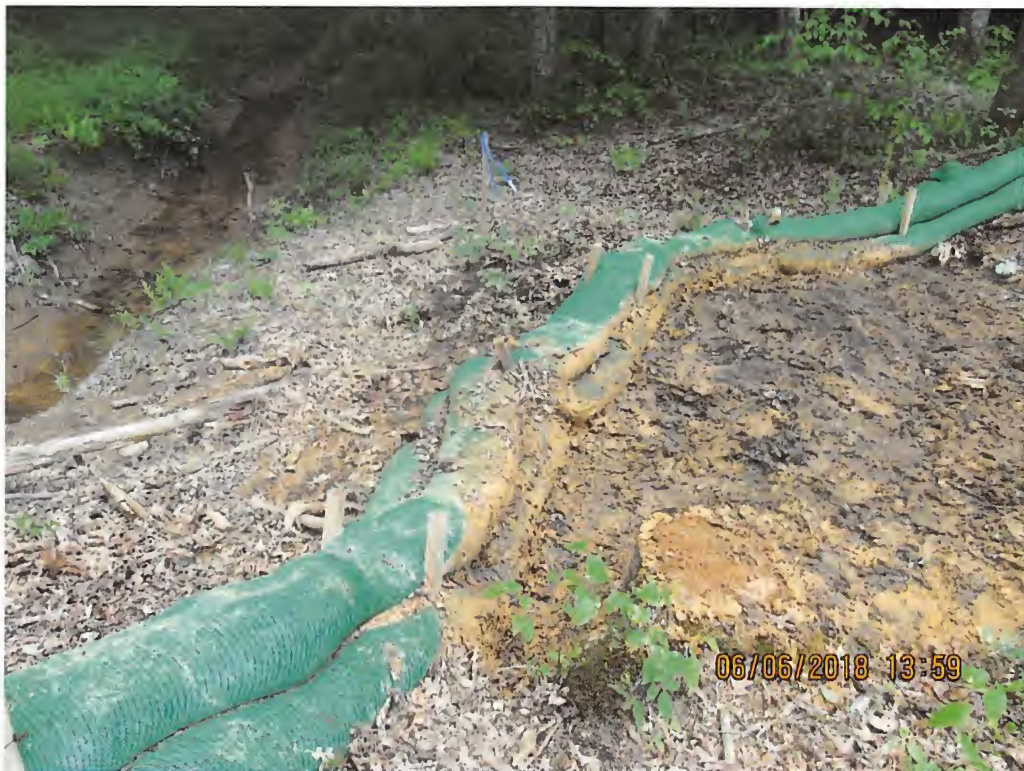
Photo 1: Station 6782+00 control failure repair but additional controls not added.

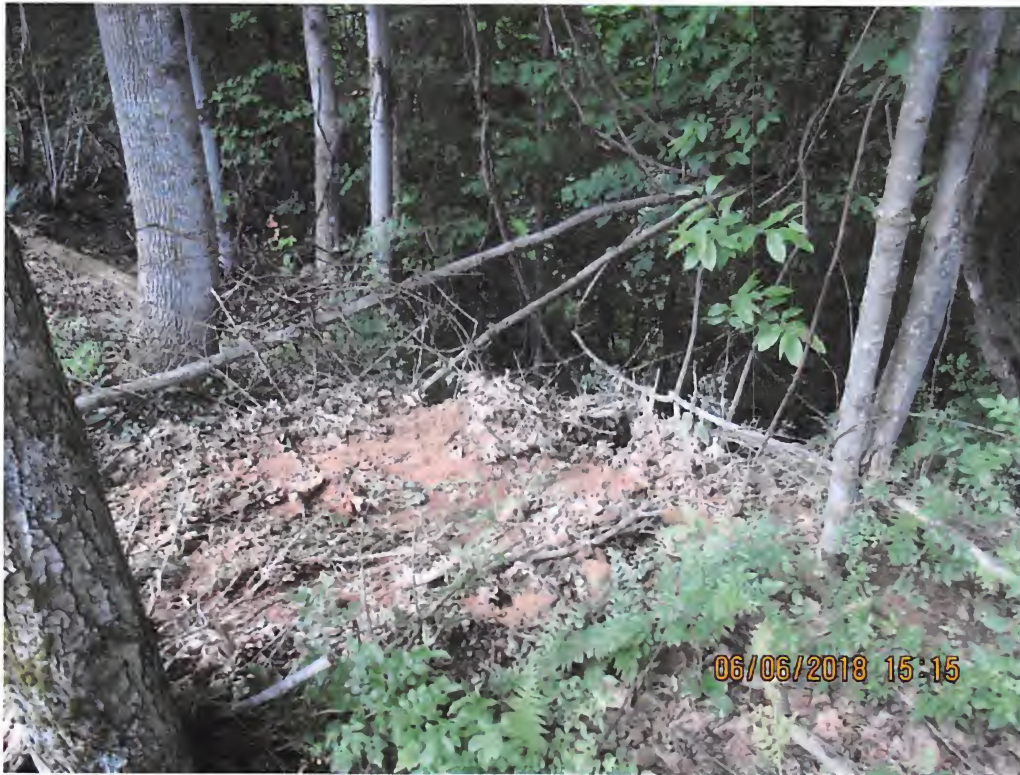
Photo 6: Continued scoured path from control failure at station 6812+58.

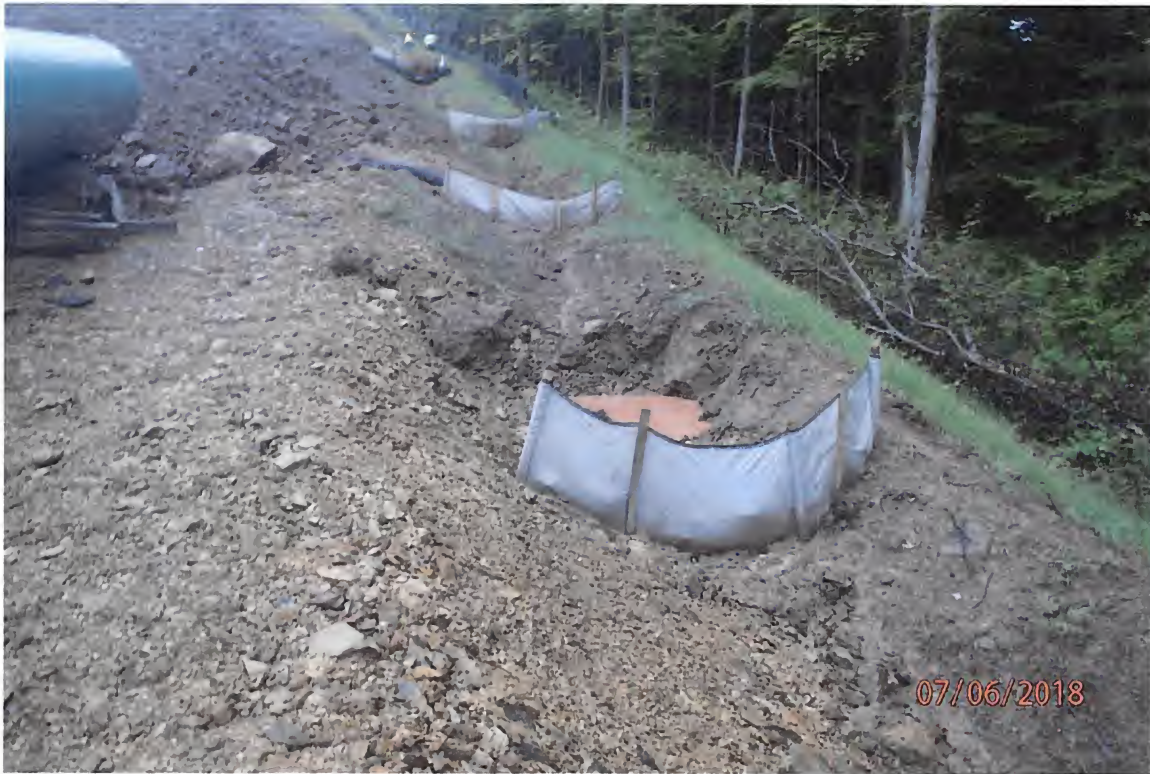
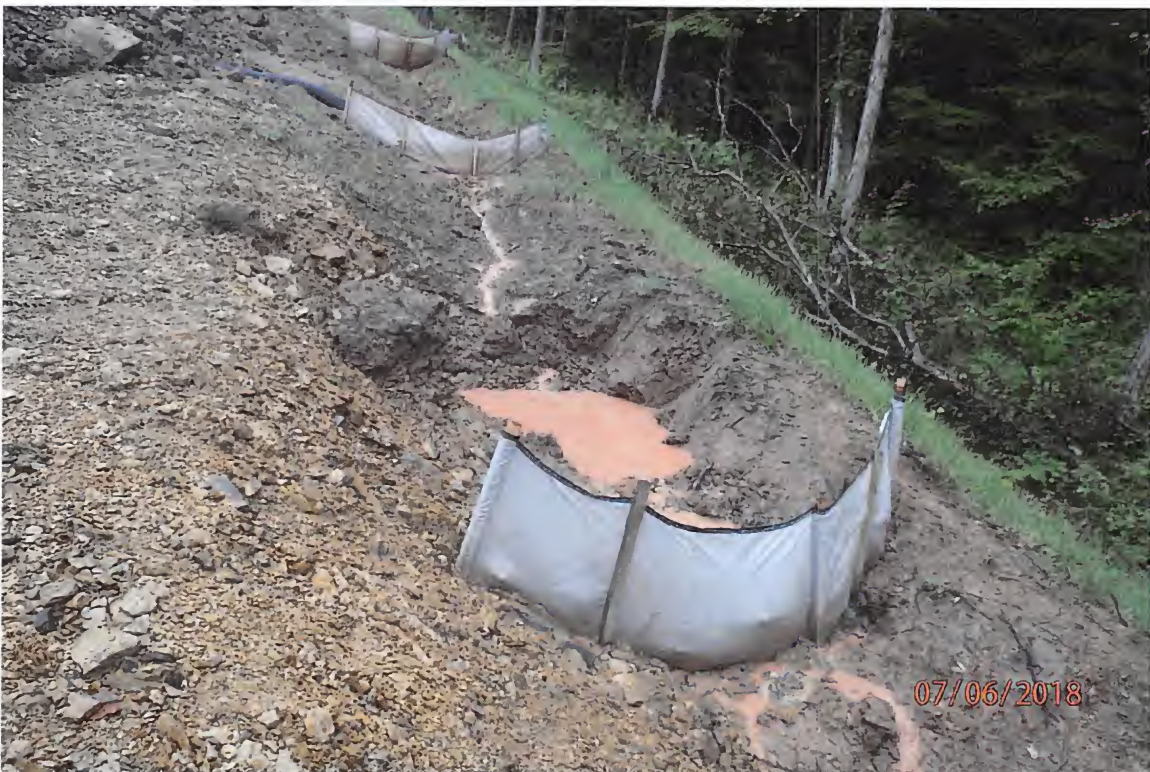
- d. Section G.4.e.2.A.ii.j - MVP failed to prevent sediment-laden water from leaving the site without going through an appropriate device at stations 6812+58 (sheet 6.38) and 6854+00 (sheet 6.39).

Photo 8: Control failure near station 6854+00 where sediment laden water left site.

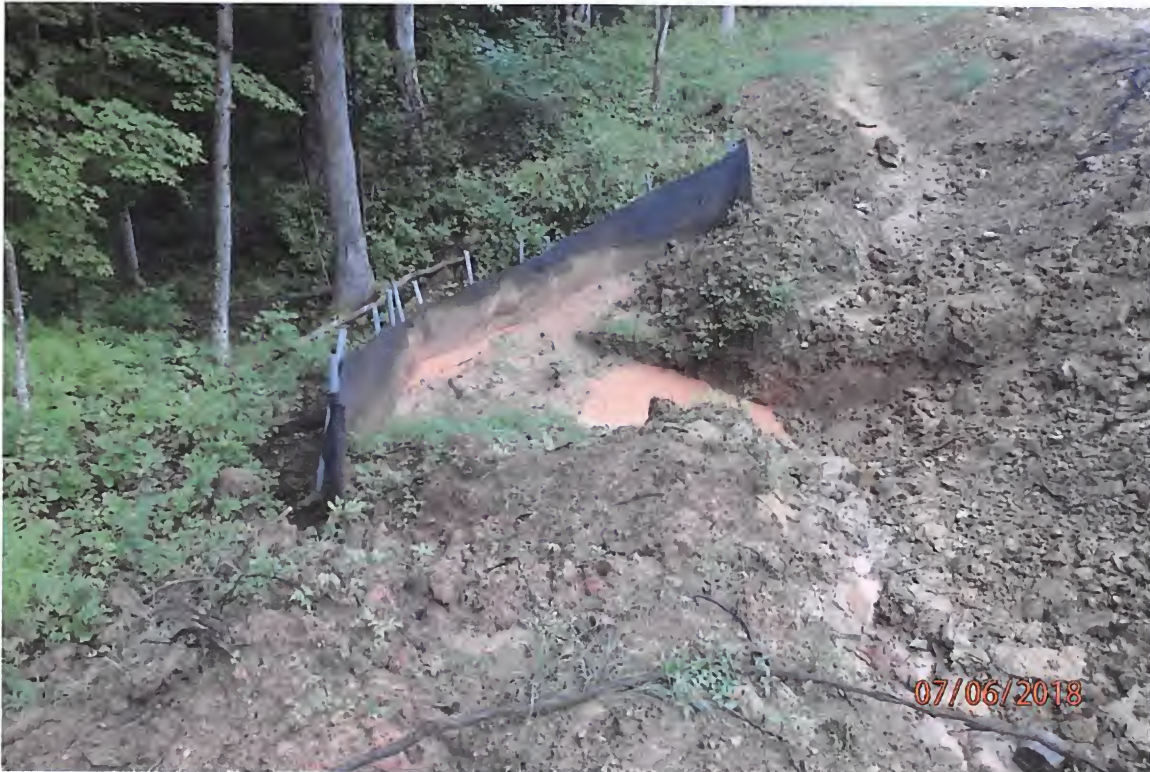
- b. Section D.1 - MVP failed to operate and maintain all erosion control devices. An improperly operated temporary right of way diversion and outlet were noted at 1851+00. This deficiency caused sediment laden water to leave the site, which resulted in sediment in the stream.

The installed temporary right of way diversion and outlet adjacent to 1851+00 that was collecting stormwater from multiple water bars without adequate outlets. This caused concentrated flow to overwhelm the installed BMP at the base of the slope.

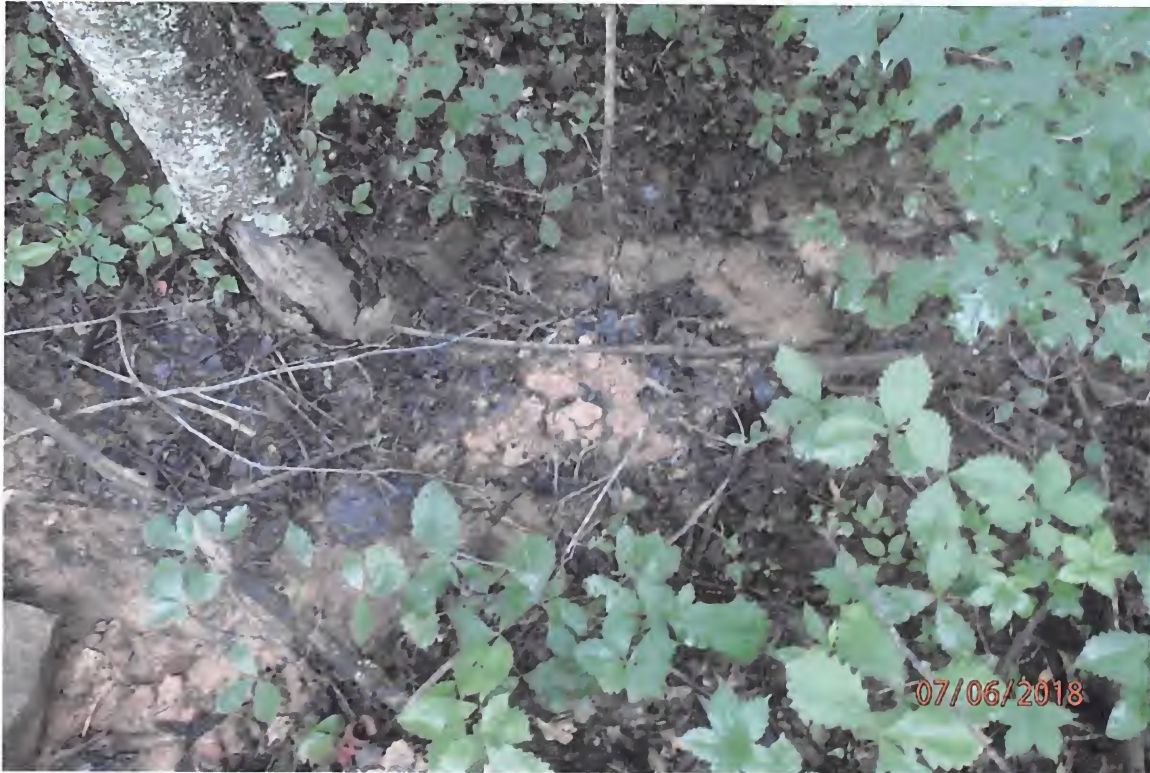
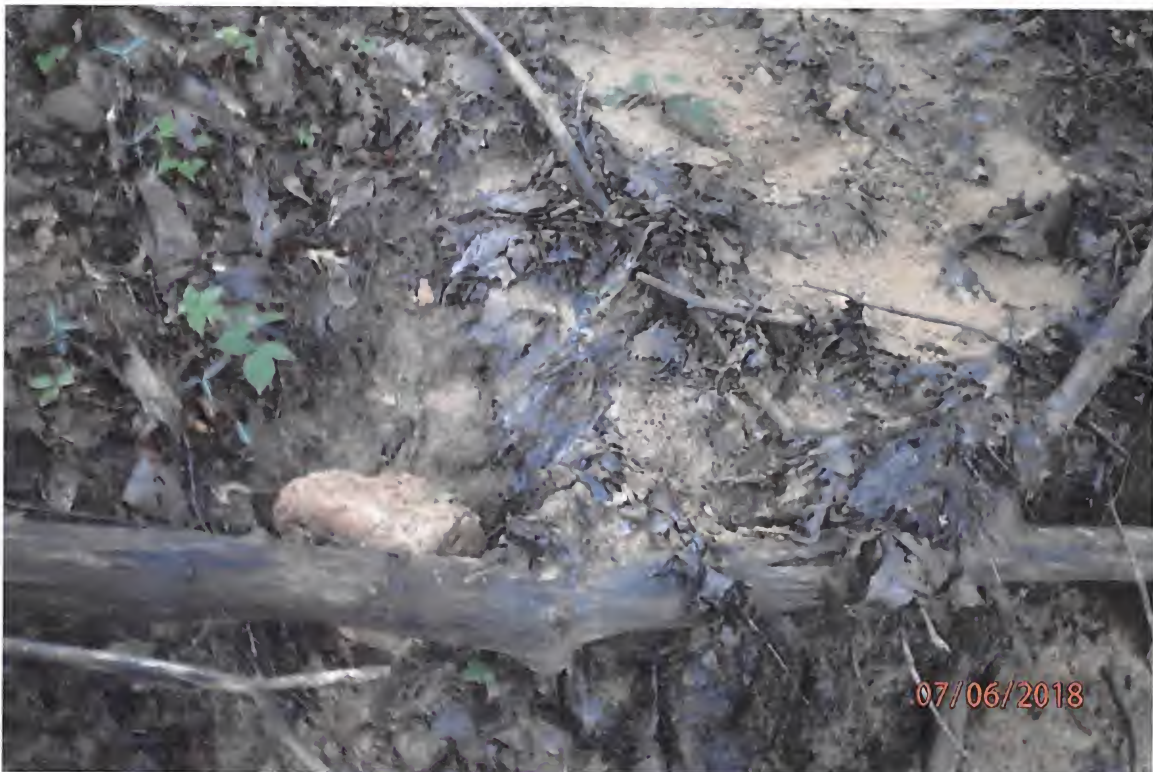
- a. Section G.4.e.2 - MVP failed to properly implement controls. Improperly installed water bars were present throughout the inspected area. An improperly installed BMP at the terminus of a water bar located adjacent to the Dry Fork access (MVP-DO-049) caused sediment laden water to bypass the device.

Improperly installed BMP at the terminus of a water bar adjacent to MVPDO-049 (1891+00) that allowed sediment laden water to leave the site and caused CNA in UNT Dry Fork.

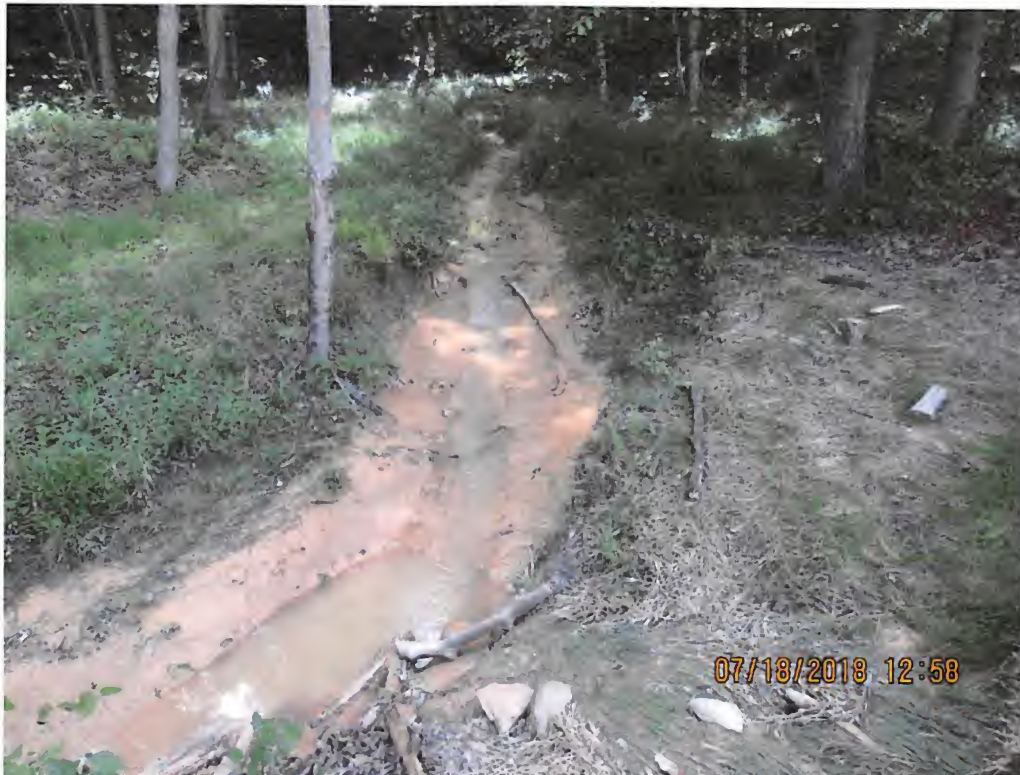
Photo 6: Sediment deposits in UNT of Harmony Creek at bridge near station 6781+87

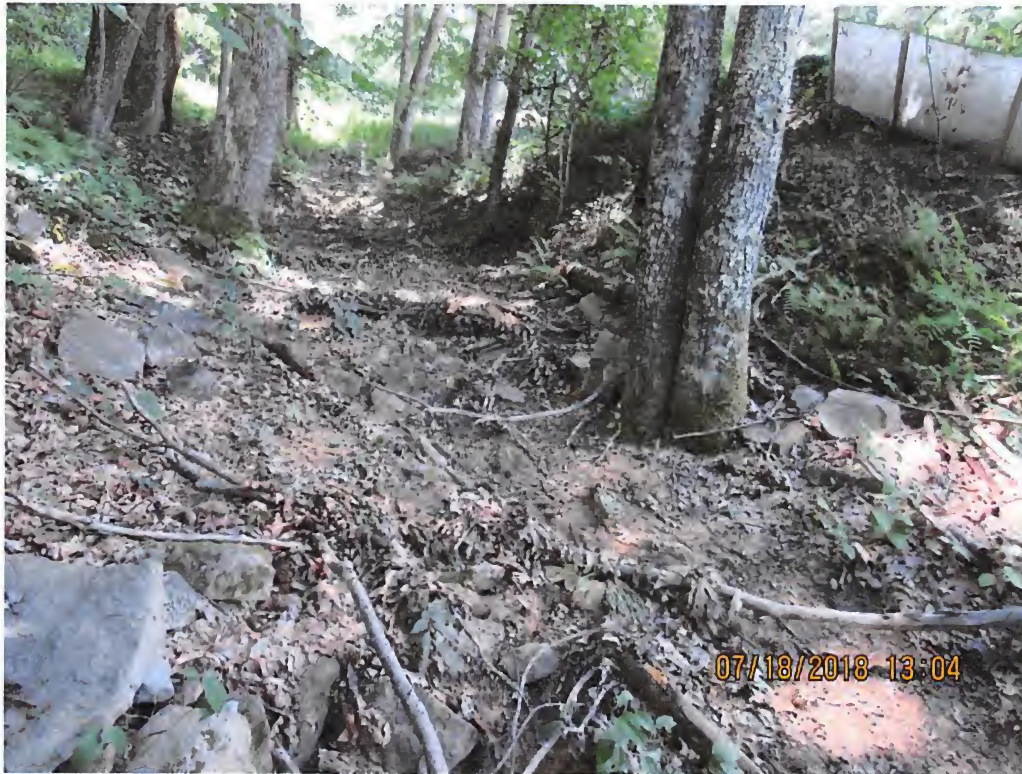
Photo 14: Sediment deposits off limits of disturbance from station 6785+50 control failure.

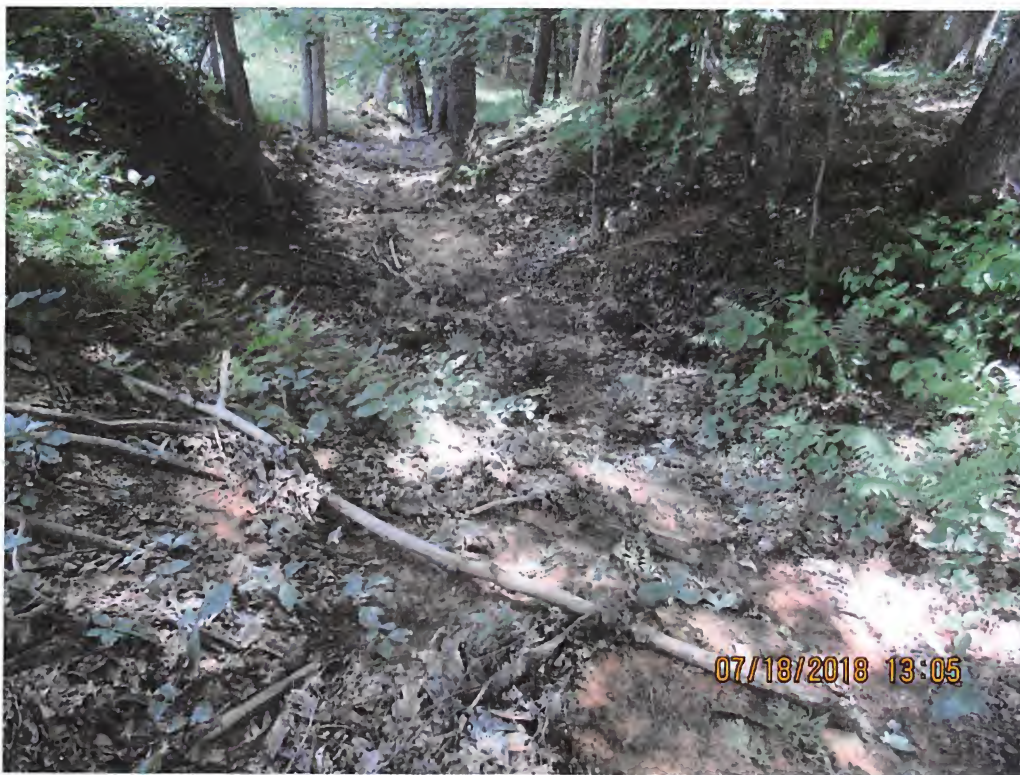
Photo 15: Scour through woods off limits of disturbance upgradient of sediment deposits in Photo 14.

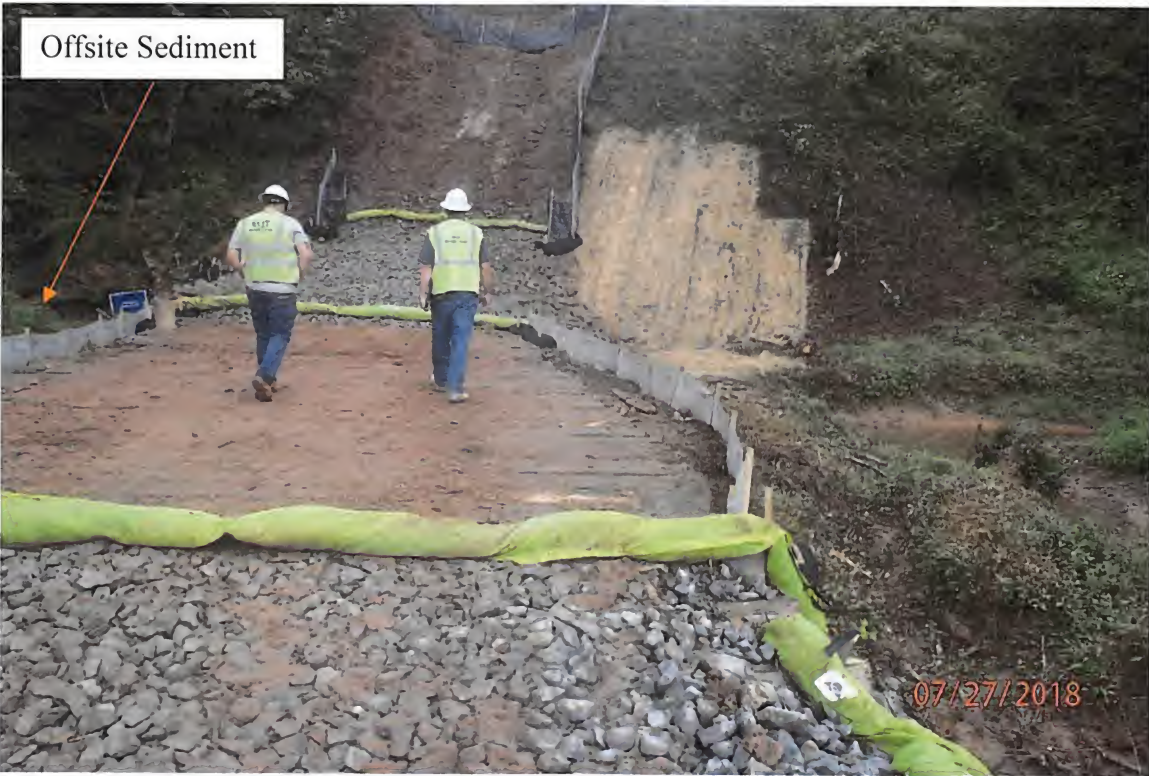
Photo 18: Installed controls at end of water bar proved inadequate and failed allowing sediment laden water to leave site.

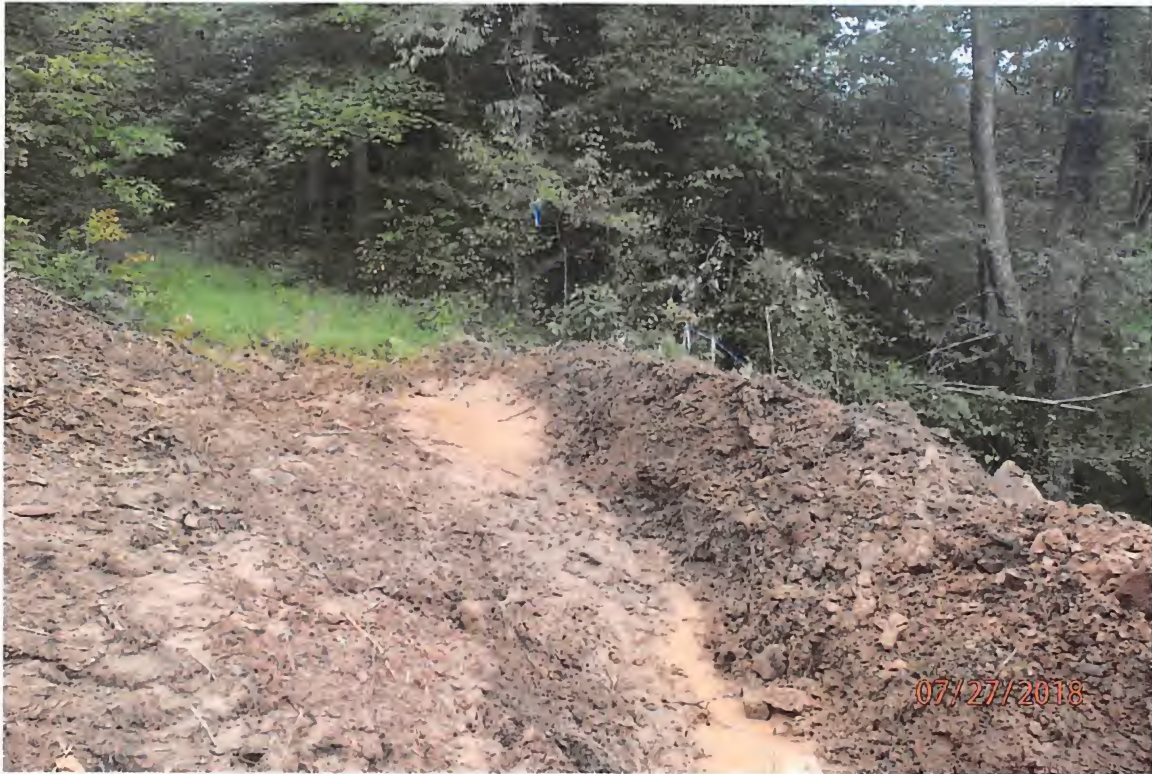
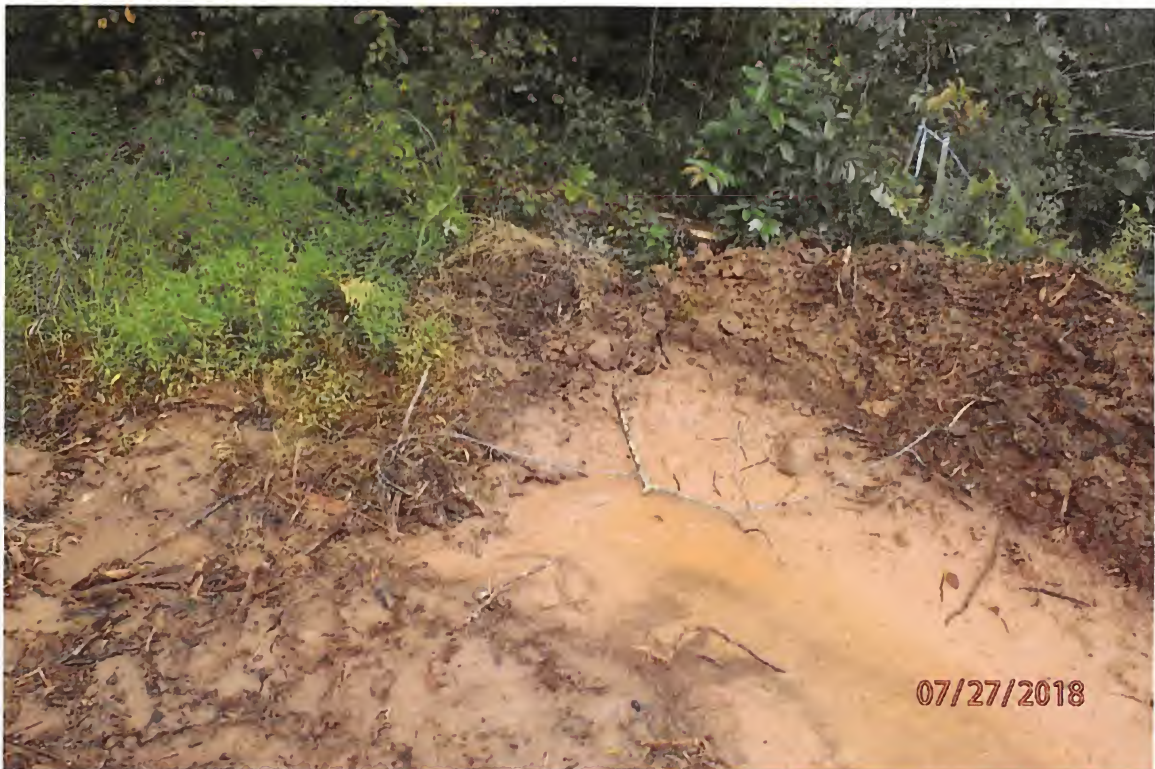
Improperly installed water bars that do not shed stormwater off site as designed.

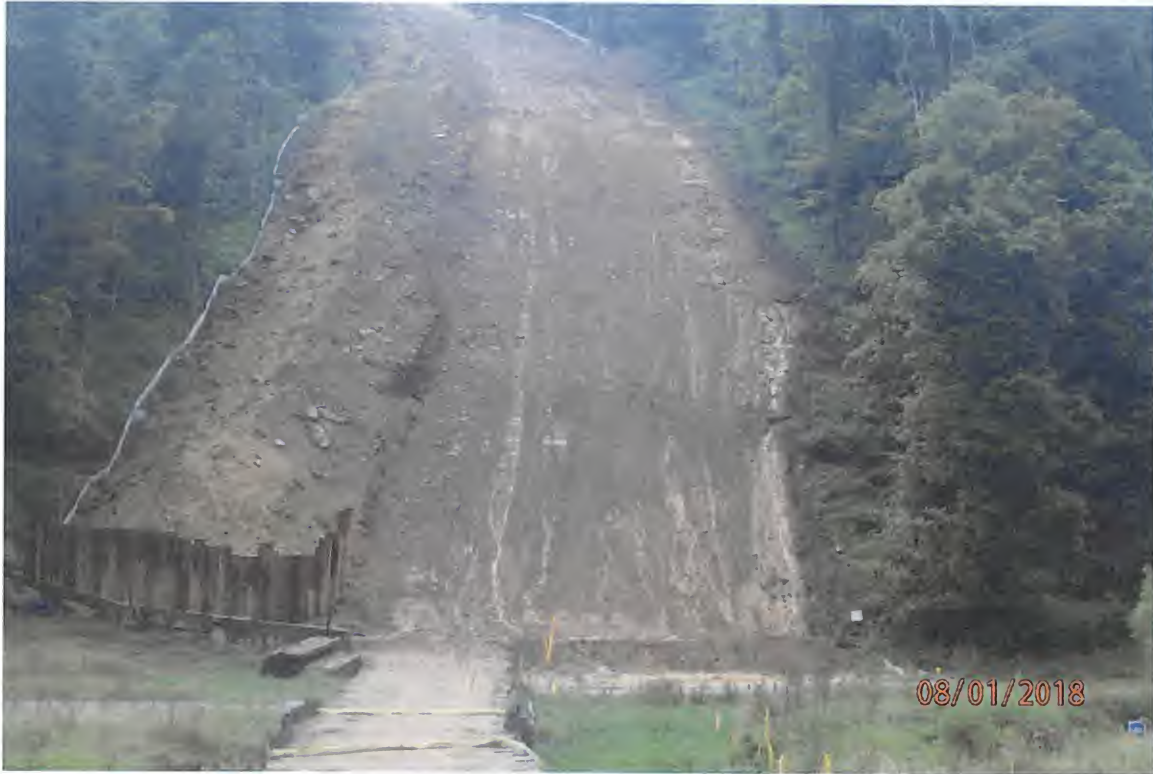
Water bar that lacked outlet protection was noted upslope of grass run adjacent to 1142+00.

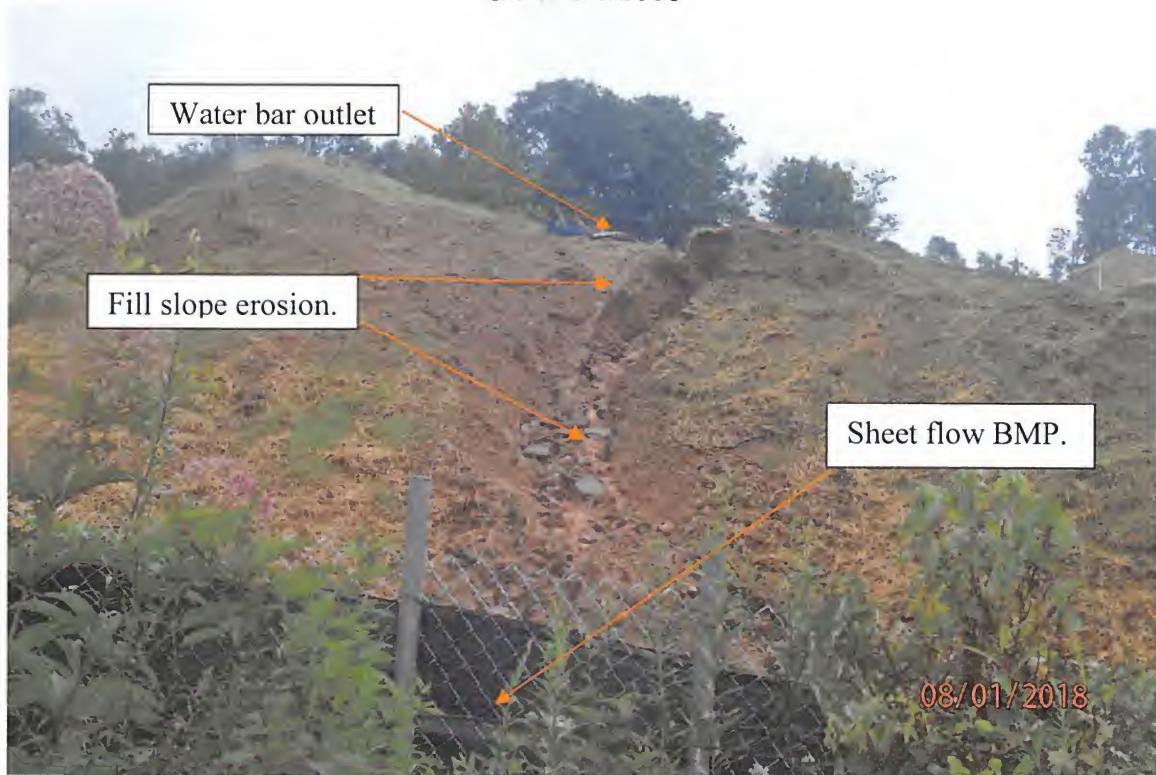
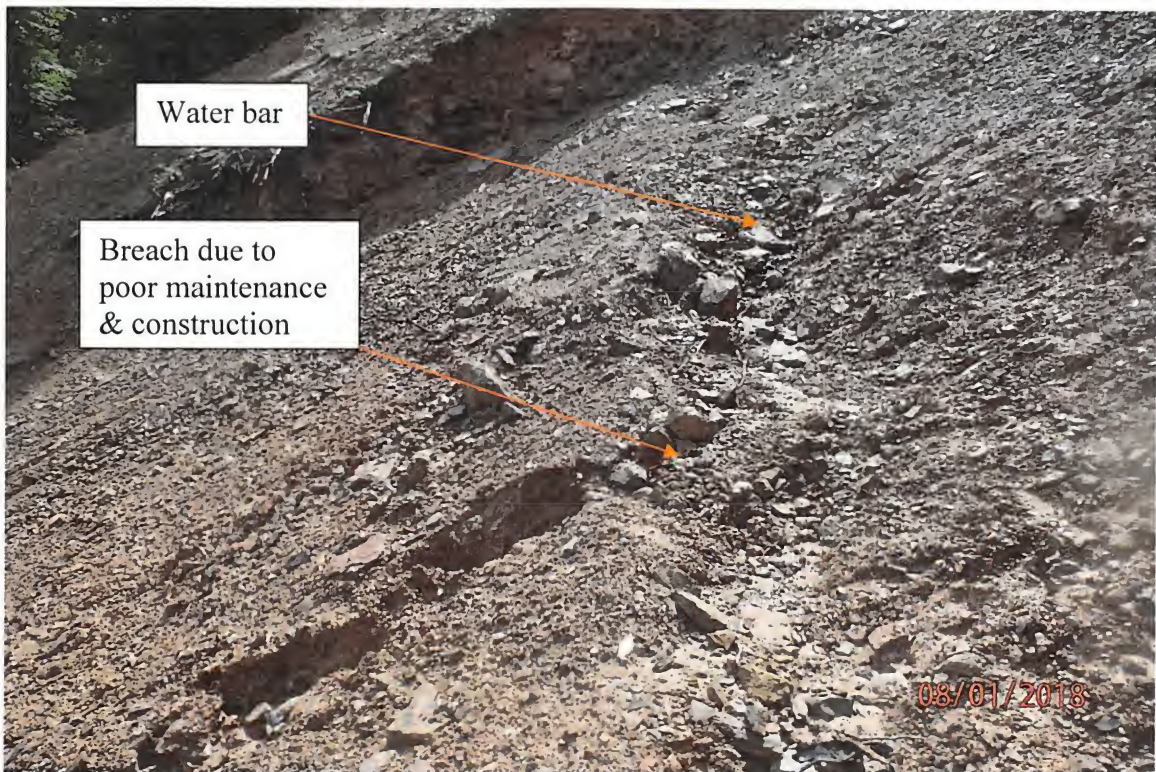
Improperly installed water bars that have caused fill slope erosion in the Big Elk Creek watershed.

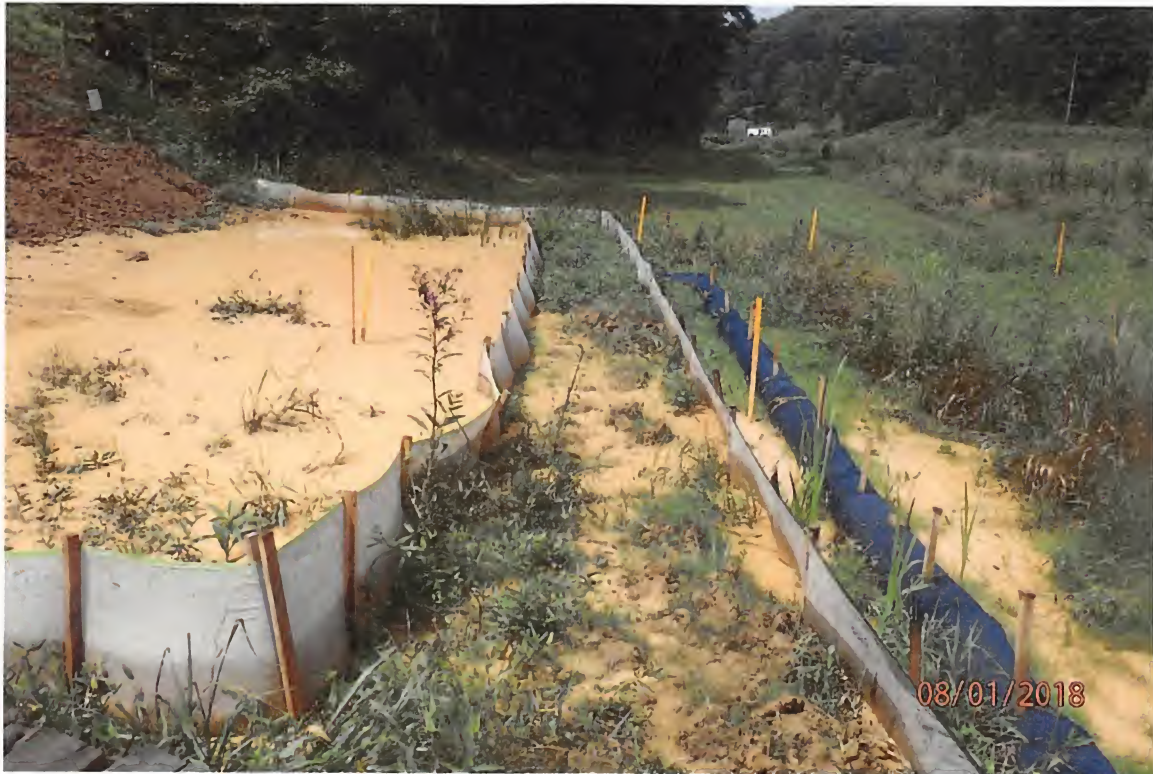
Improperly installed water bars in Big Elk Creek watershed. Improperly installed water bars that have caused fill slope erosion in the Big Elk Creek watershed.

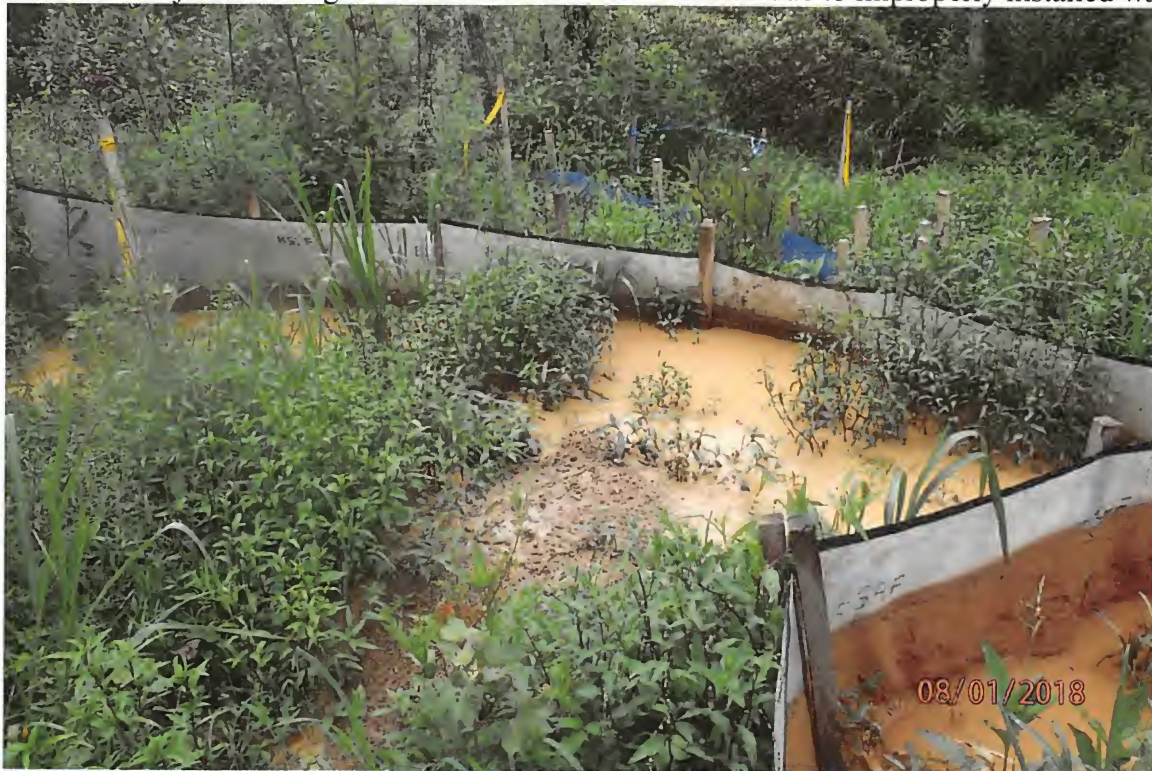
Perimeter controls adjacent to Big Elk Creek that are overwhelmed due to improperly installed water bars.

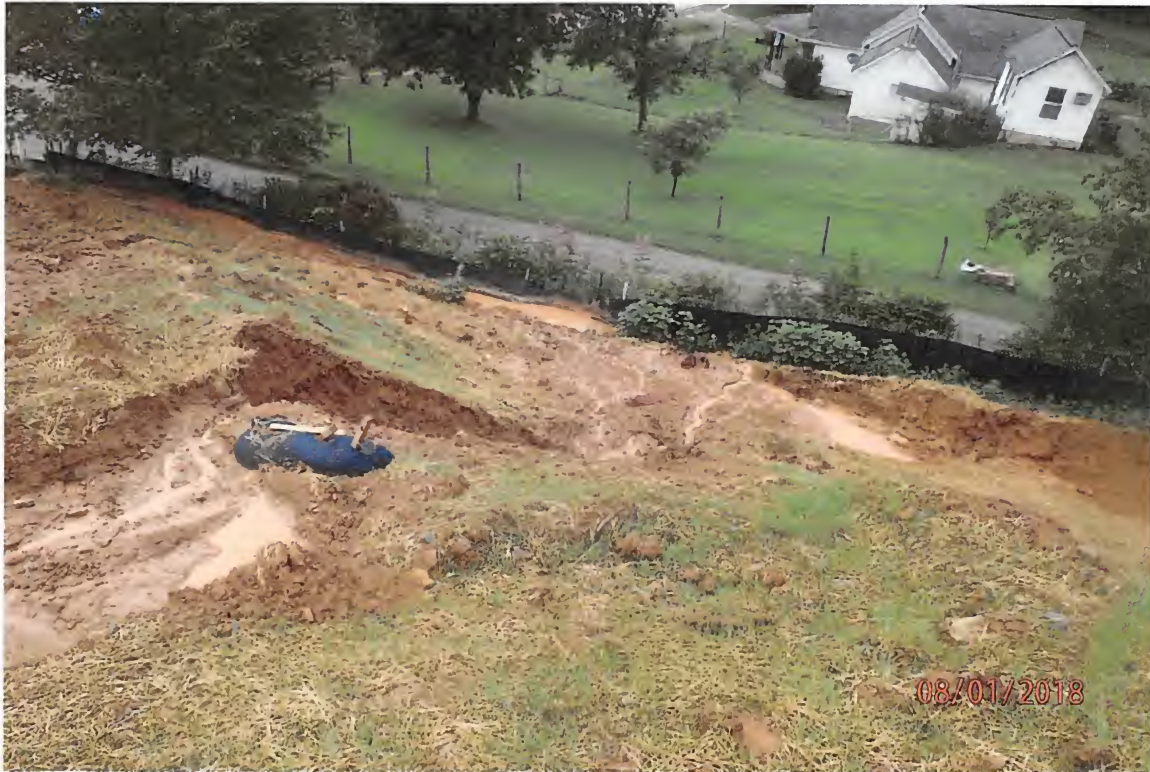
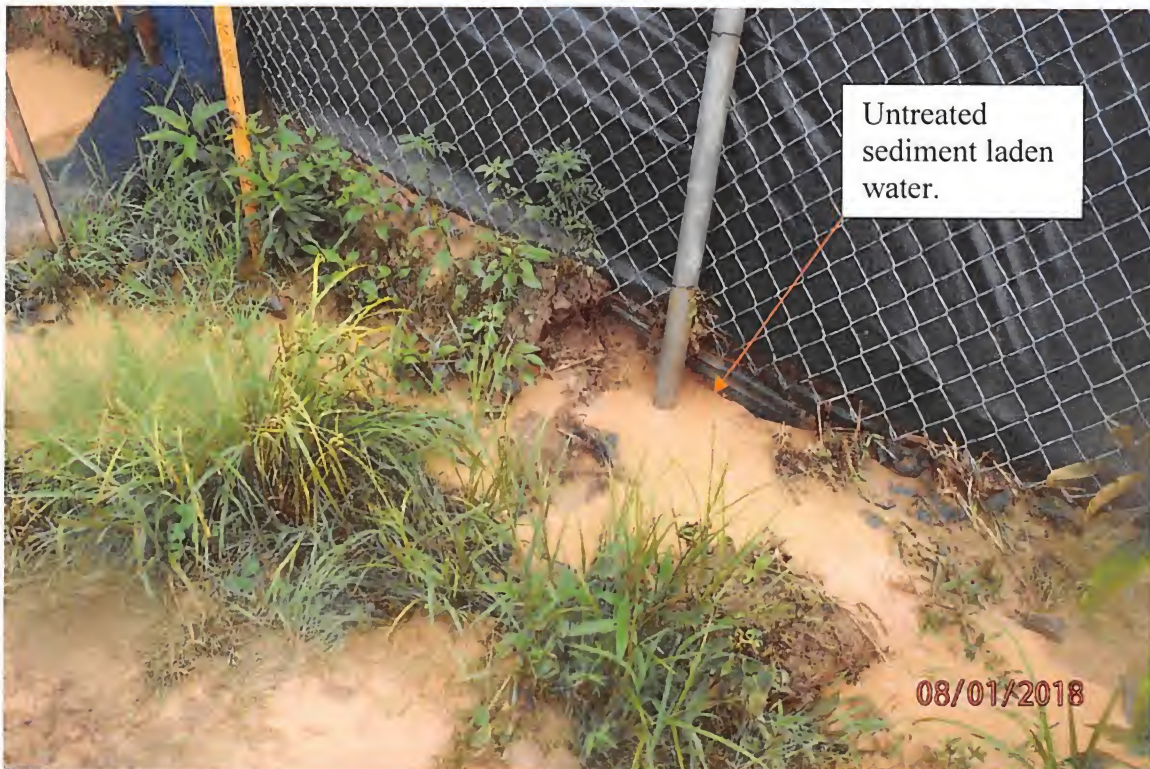
Perimeter controls adjacent to Goose Run that are overwhelmed due to improperly installed water bars.
Both pictures show BMPs that are being undermined and overwhelmed due to excessive flow that is caused by improperly installed water bars.

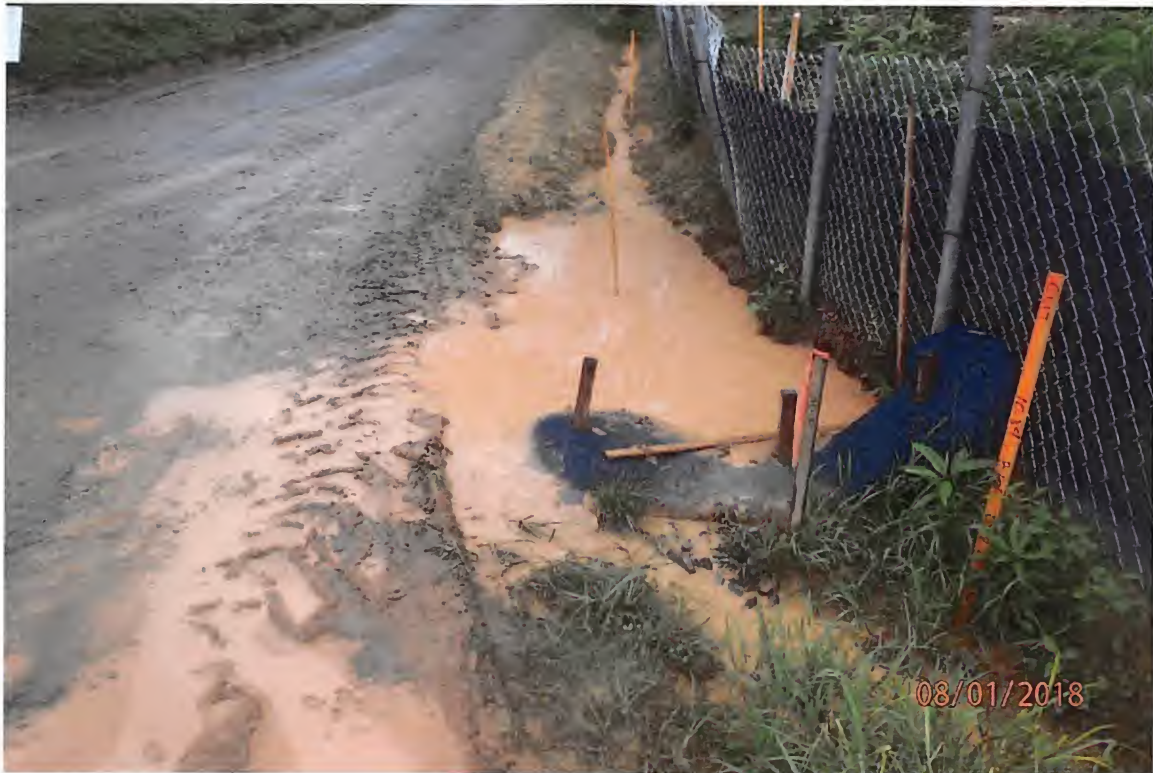
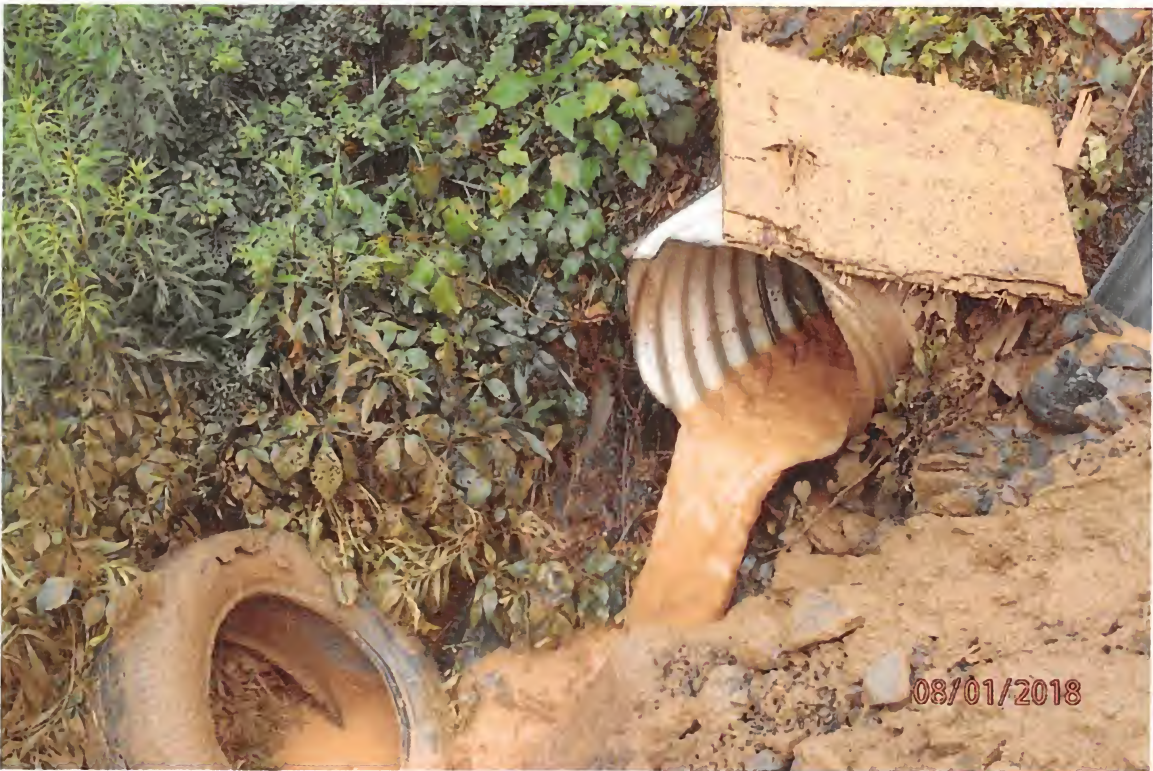
Concentrated flow from water bar outlet that is being treated by sheet flow BMP in the Big Elk Creek watershed.

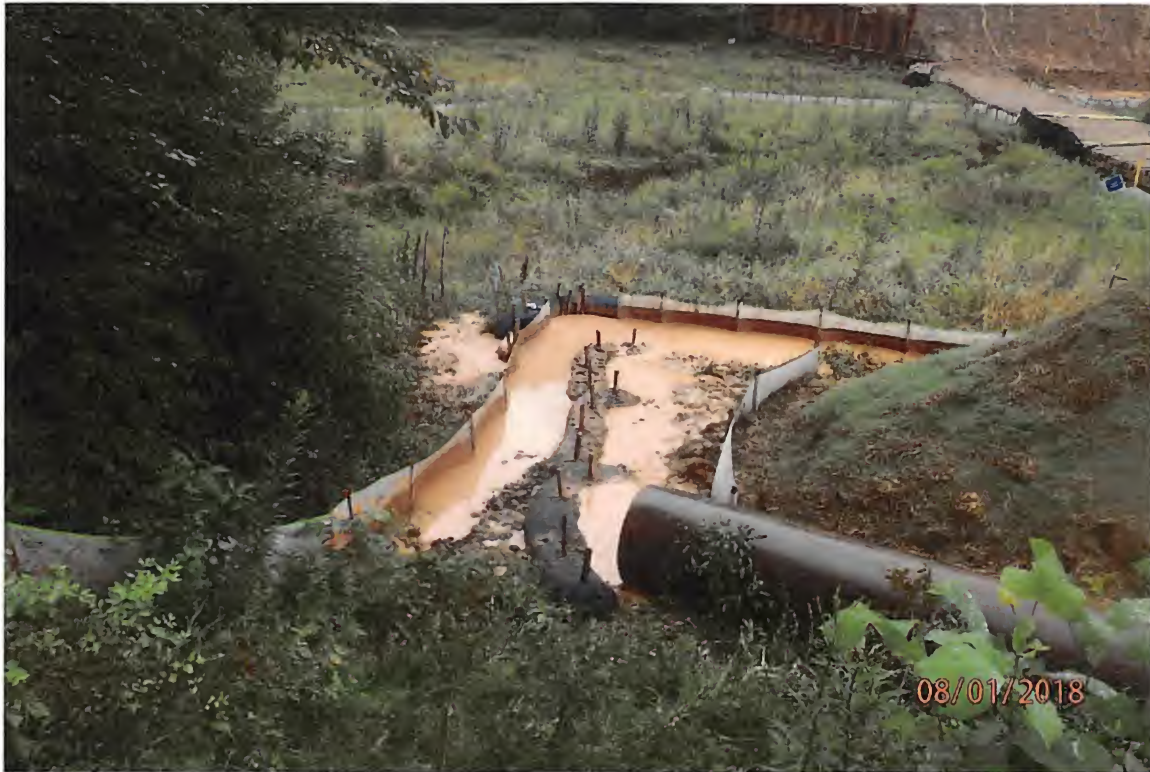
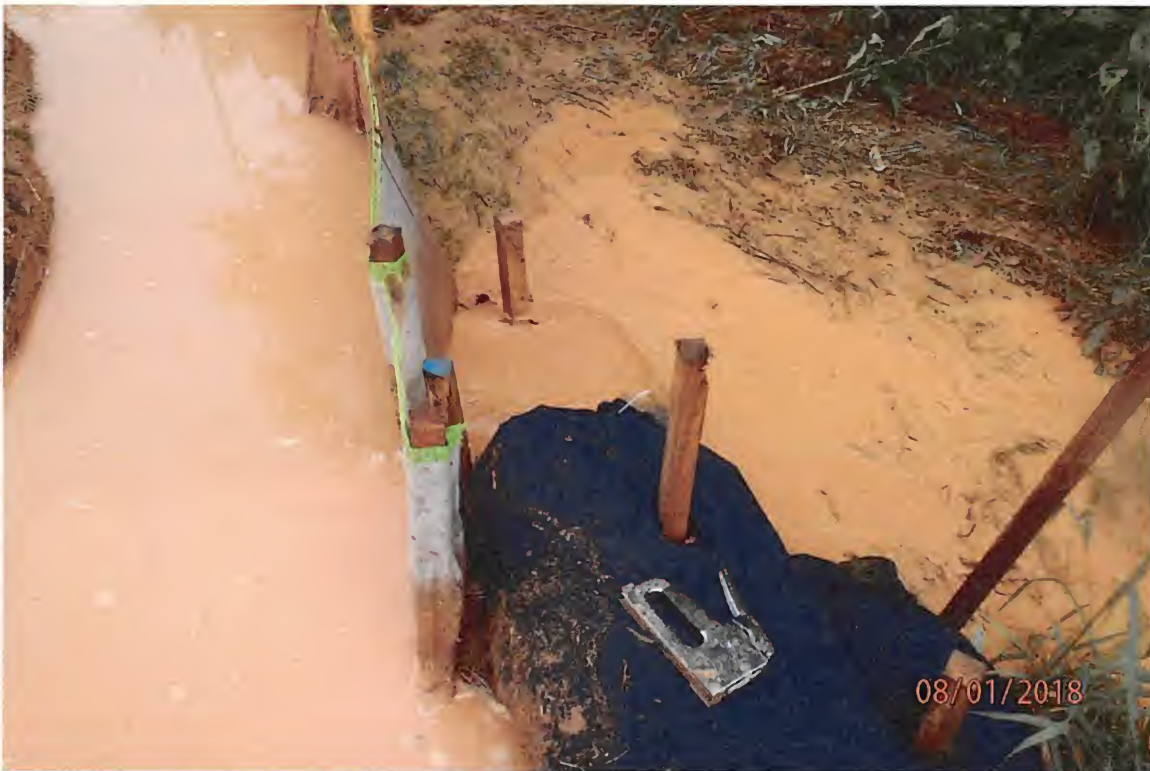
Sediment laden water that is bypassing the installed BMPs due to improper BMP operation and installation.
